Nyrstar Hobart HGP 6A/6B Rebuild

June - July 2017

Project Brief

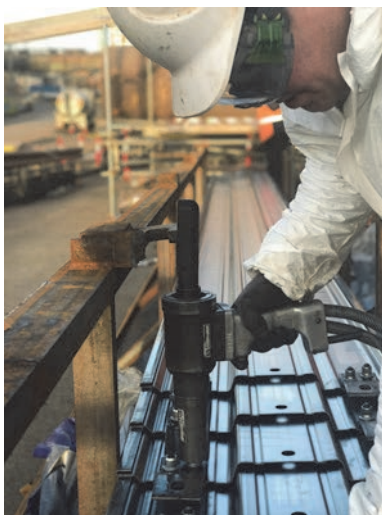
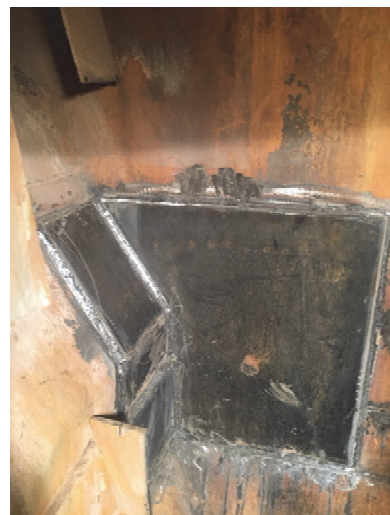
Extensive Casing repairs

Due to the acidic nature of the gas stream there was a large amount of casing repair required for these units.
